S.S. "Lady Aida"
Report - No. 3585

Midship Section No. 4585

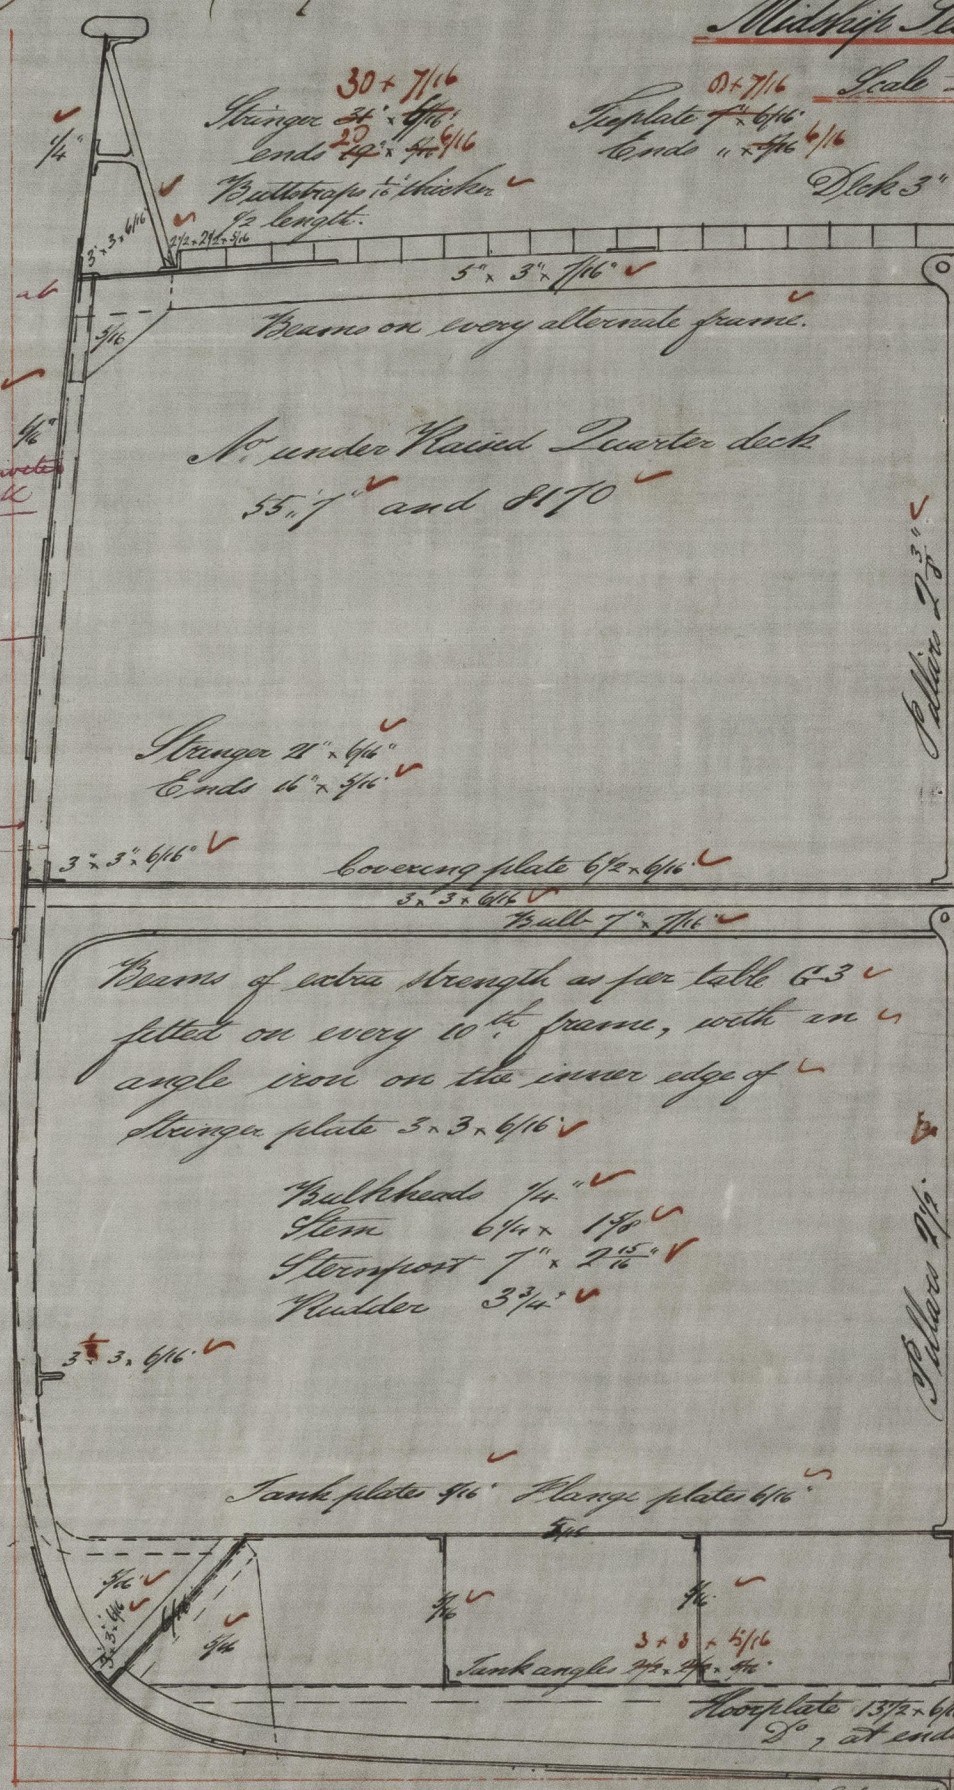
Main on every alternate frame.			
Length on Main Deck	147' 0"		
Breadth extreme	22' 8"		
" Moulded	22' 0"	B = 11.0	
Depth to top of keel	14' 0"	D = 14.0	
" " floor	12' 10 1/2"	B = 22.8	
Depth	22' 8"	47' 8"	
No. 47 and 6994. 7006			
Class 90 21

Frames spaced 21" centre to centre.
Do 3' x 3' 3/4" 3/8 length amidships
Do " " 3/4" 1/2 " at ends
Reverse bar 2 1/2" x 3/4", extending to stringer
above bulge, and gunwale alternately,
and to be double to turn of bulge, in
Engine room.

Keelson 10" x 1/2"
Under Keelson 6 1/2" x 3/4"
Keelson angle 3' x 3' 3/4"

Keelson plate 13 1/2" x 3/4"
Do, at ends 5 1/2"

Keel 7' 1 1/2"
30' 9/16"
fore ends 1/2"

Keel ends 6 1/2"
Saps of plating from keel to upper turn
of bulge double riveted.

Stringer 30 x 7/16
ends 1 1/2"
Bultraps to thicken & lengthen.
Vessel to be strengthened at
break as per Sec. 45.
Double riveted

Saps of plating from upper turn
of bulge to keelson angle riveted.

20/9/75
Thickness of shell plating
to be altered to the Plate
for 90 At grade. 11/89

Sole
strengthened at
break as
required by
Sec. 45
Suble riveted
at break
