REPORT of SURVEY for REPAIRS.

No. in Reg. Book. **No.** 286 Survey held at London Date August 28th 18 67
on the S. Lancelles Master Sleightholme
Tonnage 907 Built at Houlmein When built 1858
By whom built Dunbar Owners J. Allan
Port belonging to London Destined Voyage Calcutta
If Surveyed Afloat or in Dry Dock in Limehall and East India Docks

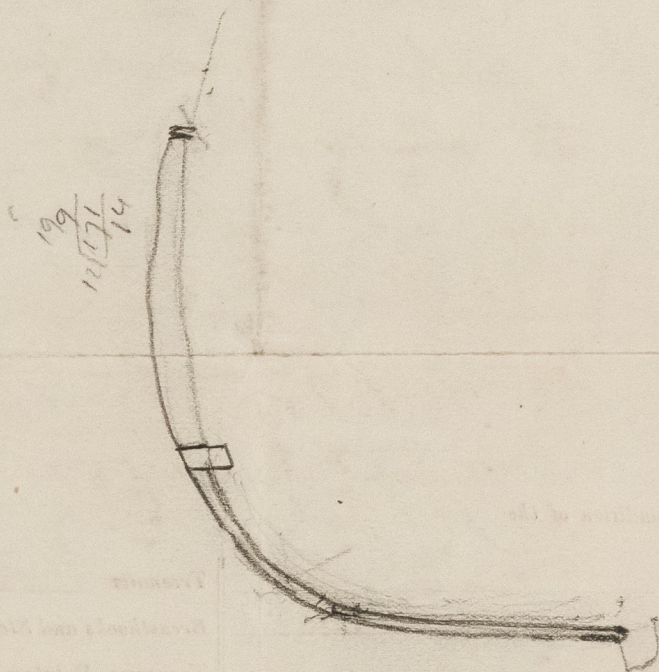
Thicknesses of doubling taken at upper edges.

1 st	an arrio piece —	in
2 nd	let in $1\frac{1}{2}$	5
3 rd	-----	$6\frac{1}{4}$
4 th	-----	$7\frac{1}{4}$
5 th	-----	$9\frac{1}{4}$
6 th	-----	$10\frac{5}{8}$
7 th	-----	11
8 th	-----	11
9 th	-----	11
10 th	-----	11
11 th	-----	11
12 th	-----	$9\frac{3}{4}$
13 th	-----	$8\frac{3}{4}$
14 th	-----	$7\frac{1}{4}$
15 th	-----	6
16 th	-----	$4\frac{1}{2}$
17 th	-----	$3\frac{1}{2}$
18 th	-----	3
19 th	-----	2
below which 1 st sheathing
