25 APR 1929
SHIPBUILDERS
PORT GLENGOW

POOP SIDE PLATING. 38" STRINGER ANGLE 3 1/2" x 3 1/2" x 36" STRINGER PLATE 36" x 36"
FCL " " 42" " " 3 1/2" x 3 1/2" x 36" " " 35" x 36"

WIS-0098

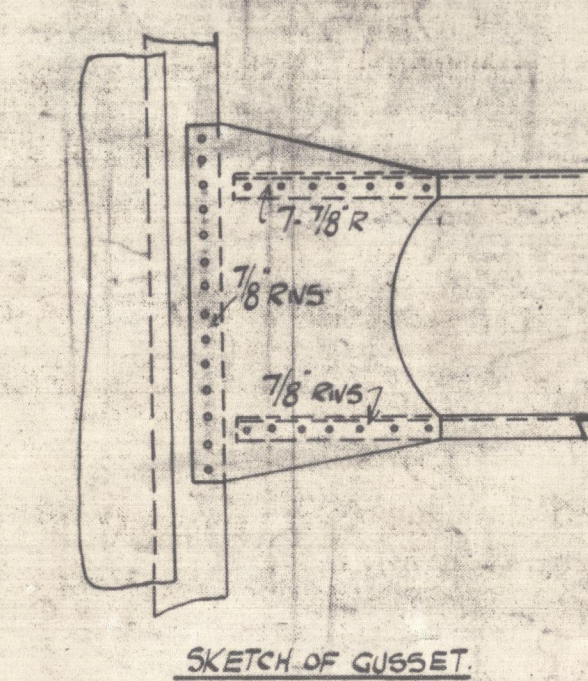
SKETCH OF GUSSET

FORGINGS
SEE SEPARATE PLANS
STEM. 9 7/8" x 2 1/2"

OF GUSSET.
