S.S. ENGINE N° E.W. 100.

MAIN ENGINE SEATING.

*N.B. Engine Works.
Glasgow.
E.W. 100
Main engine seating.*

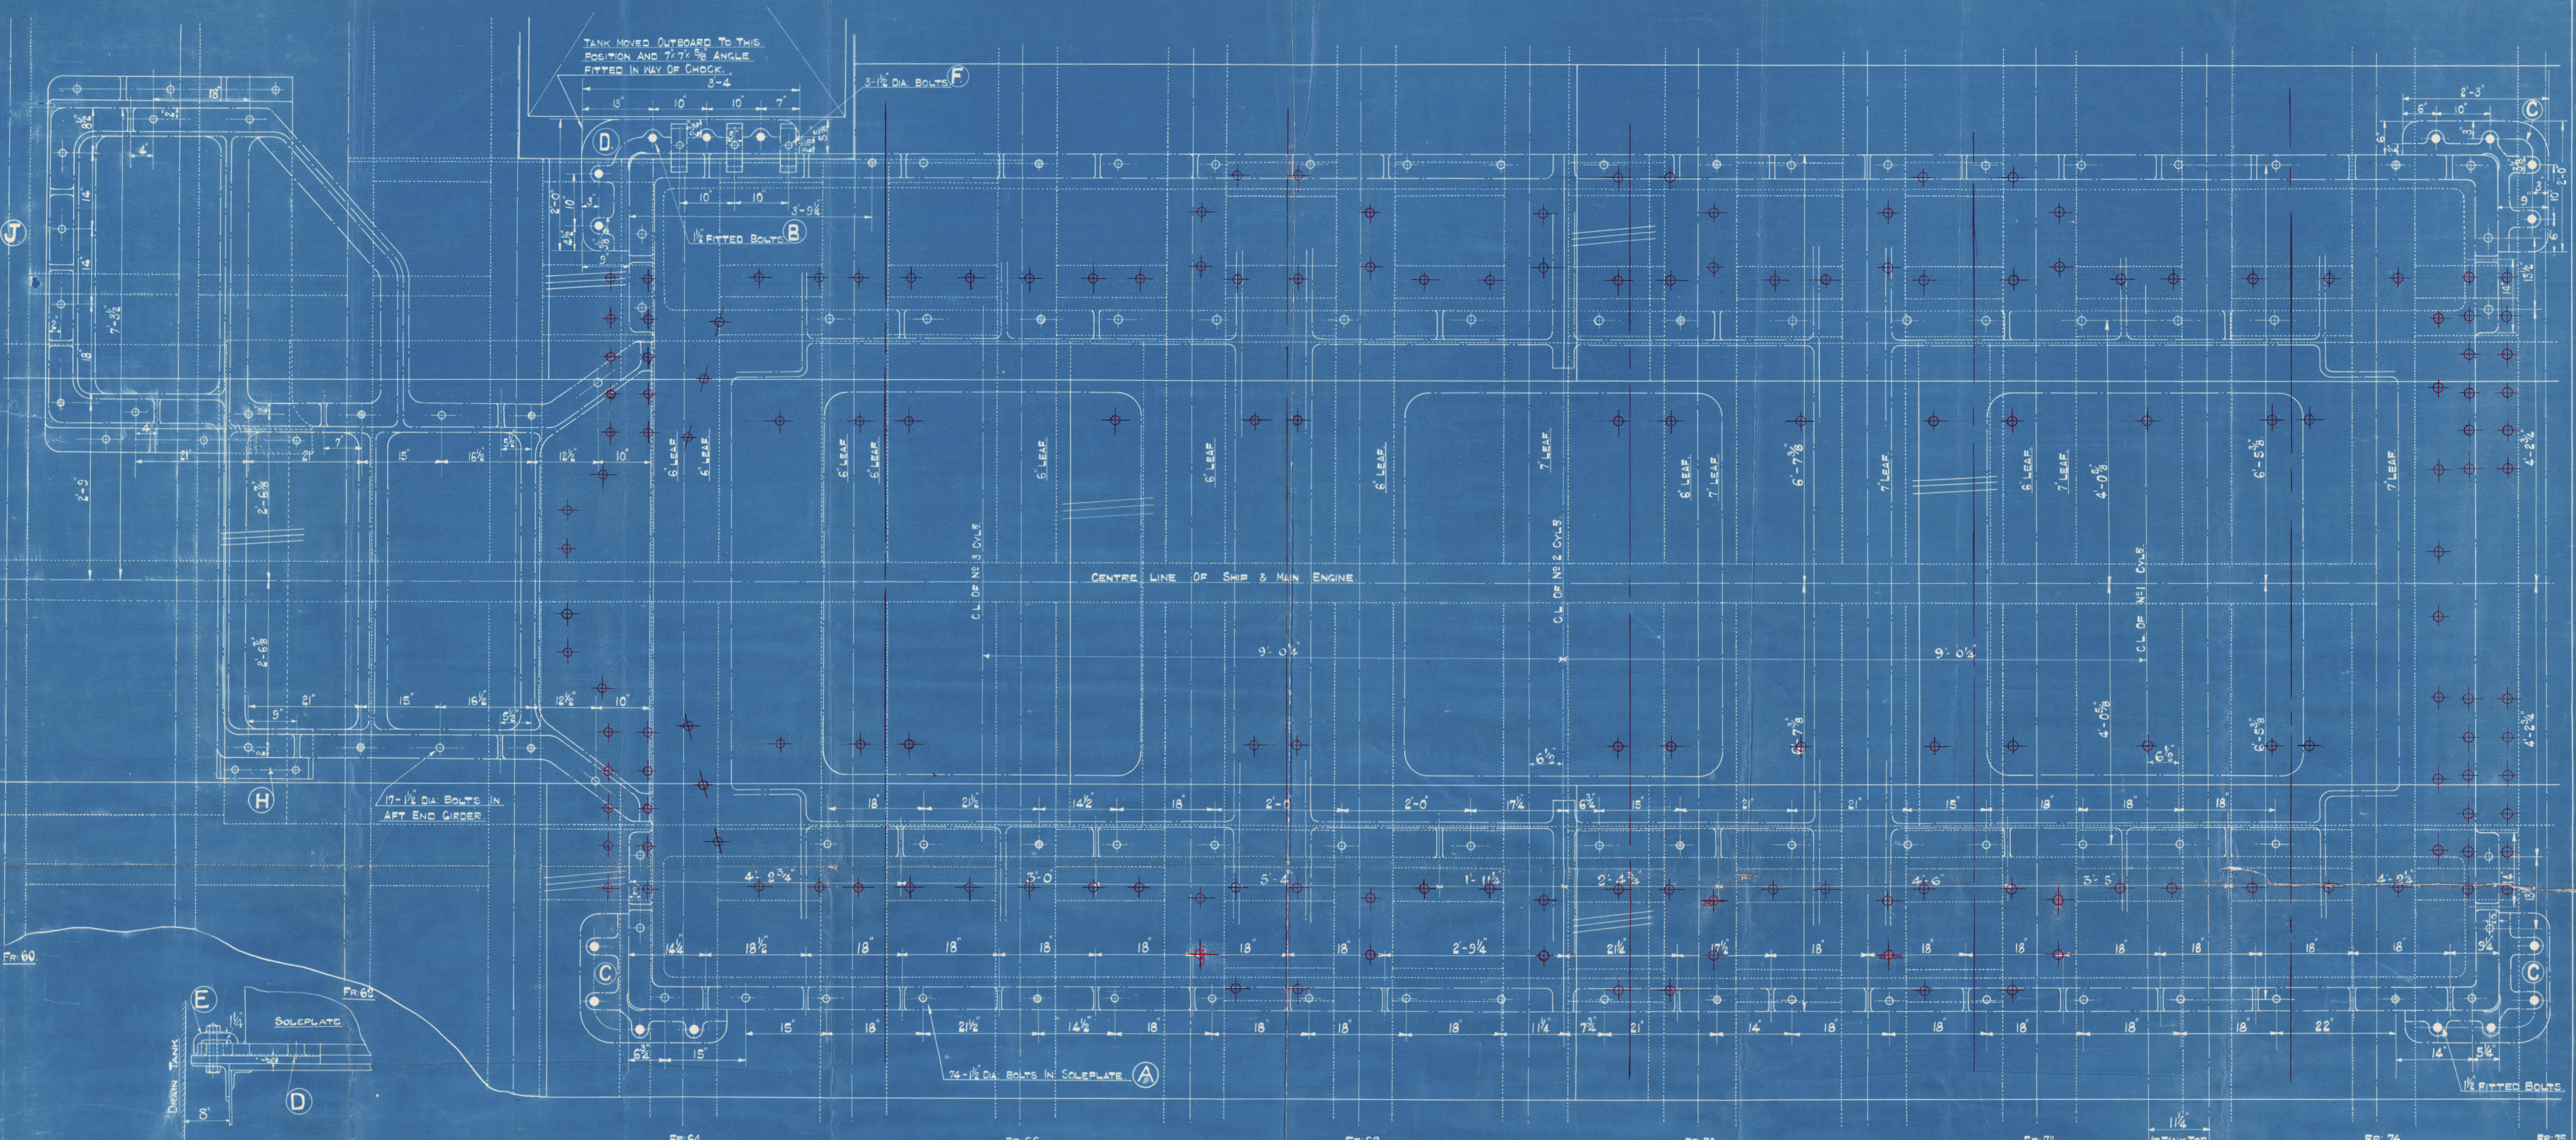
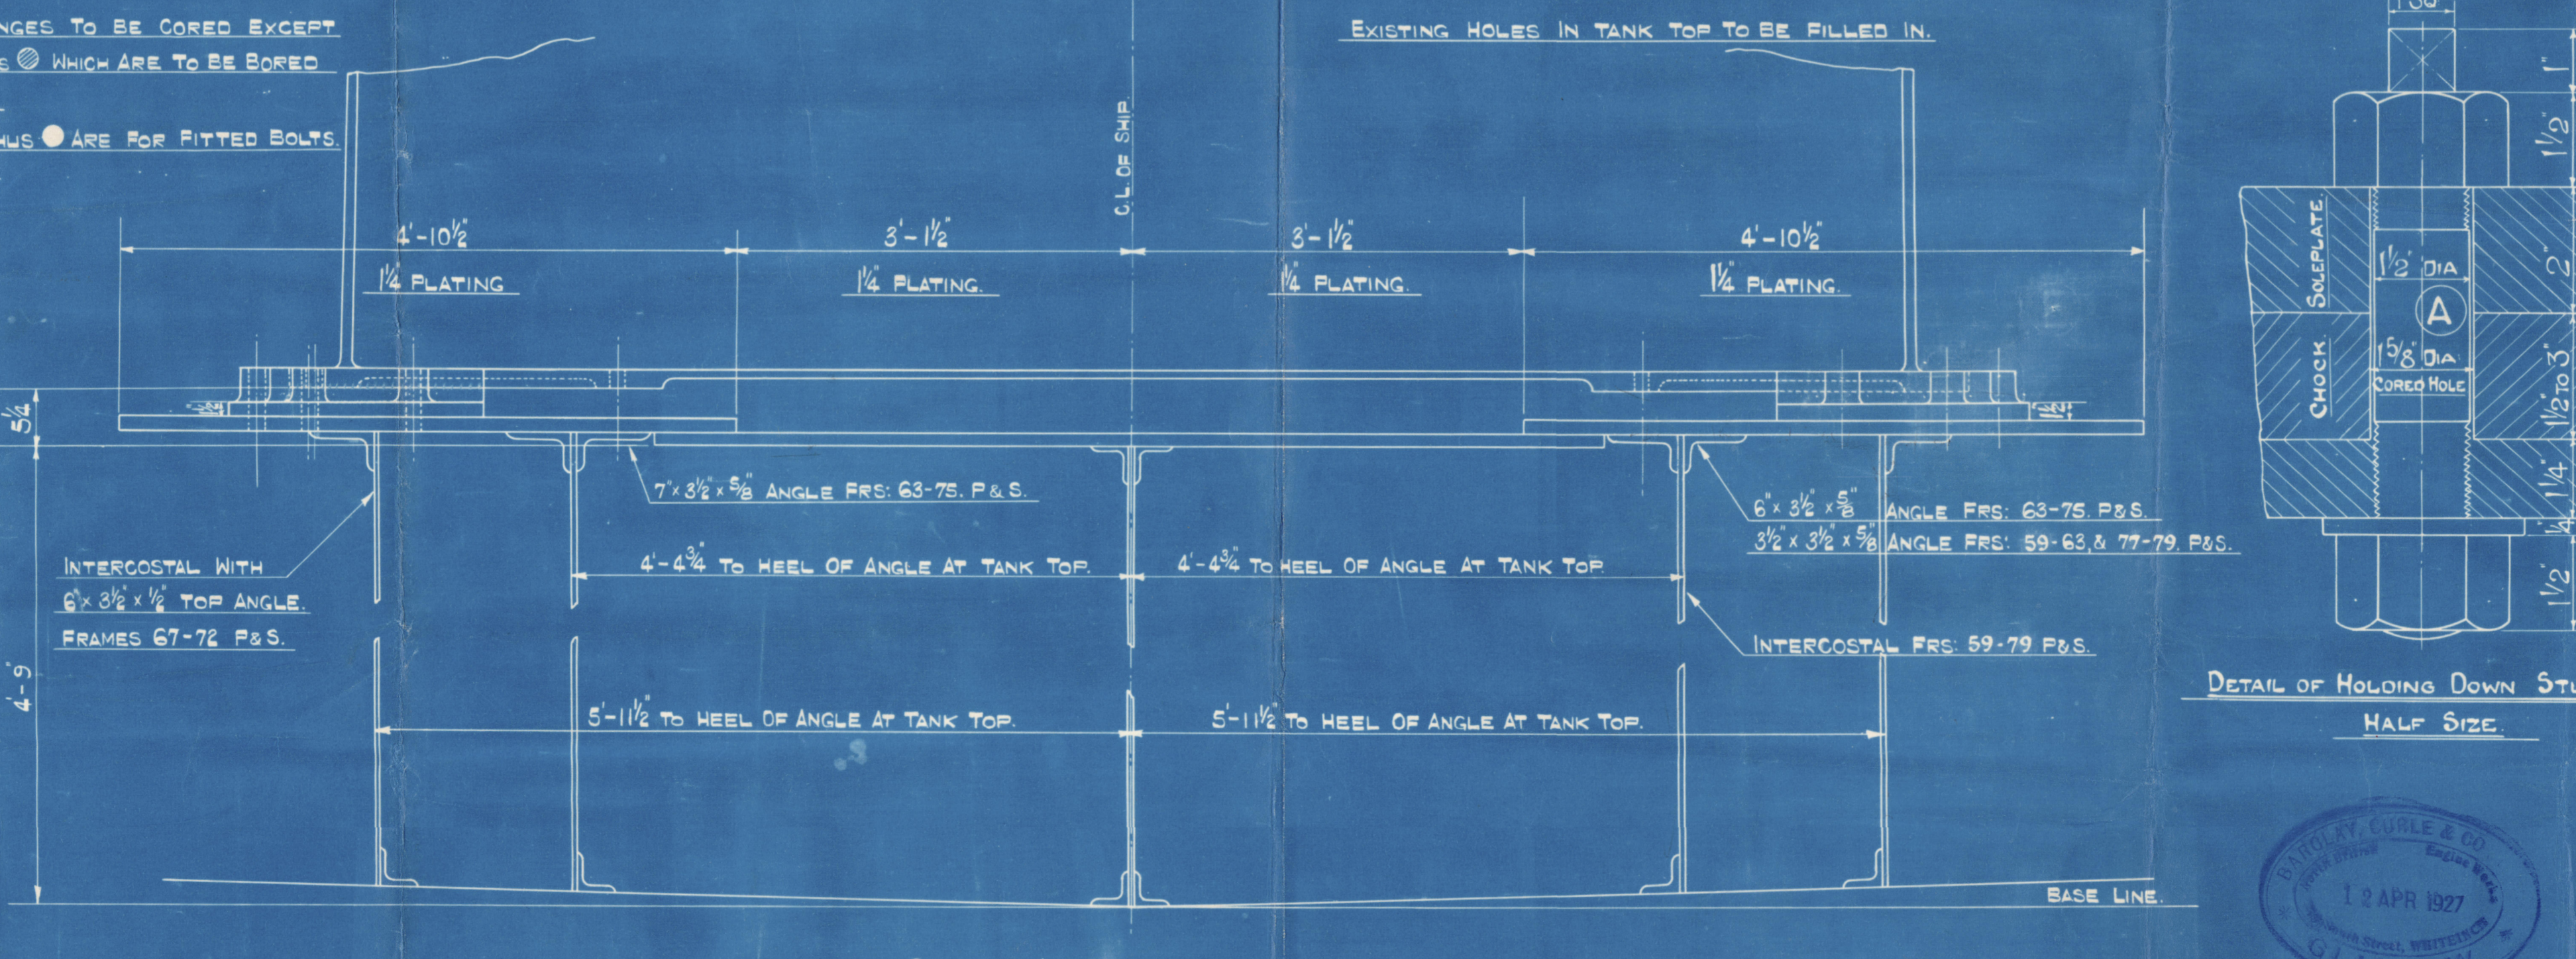
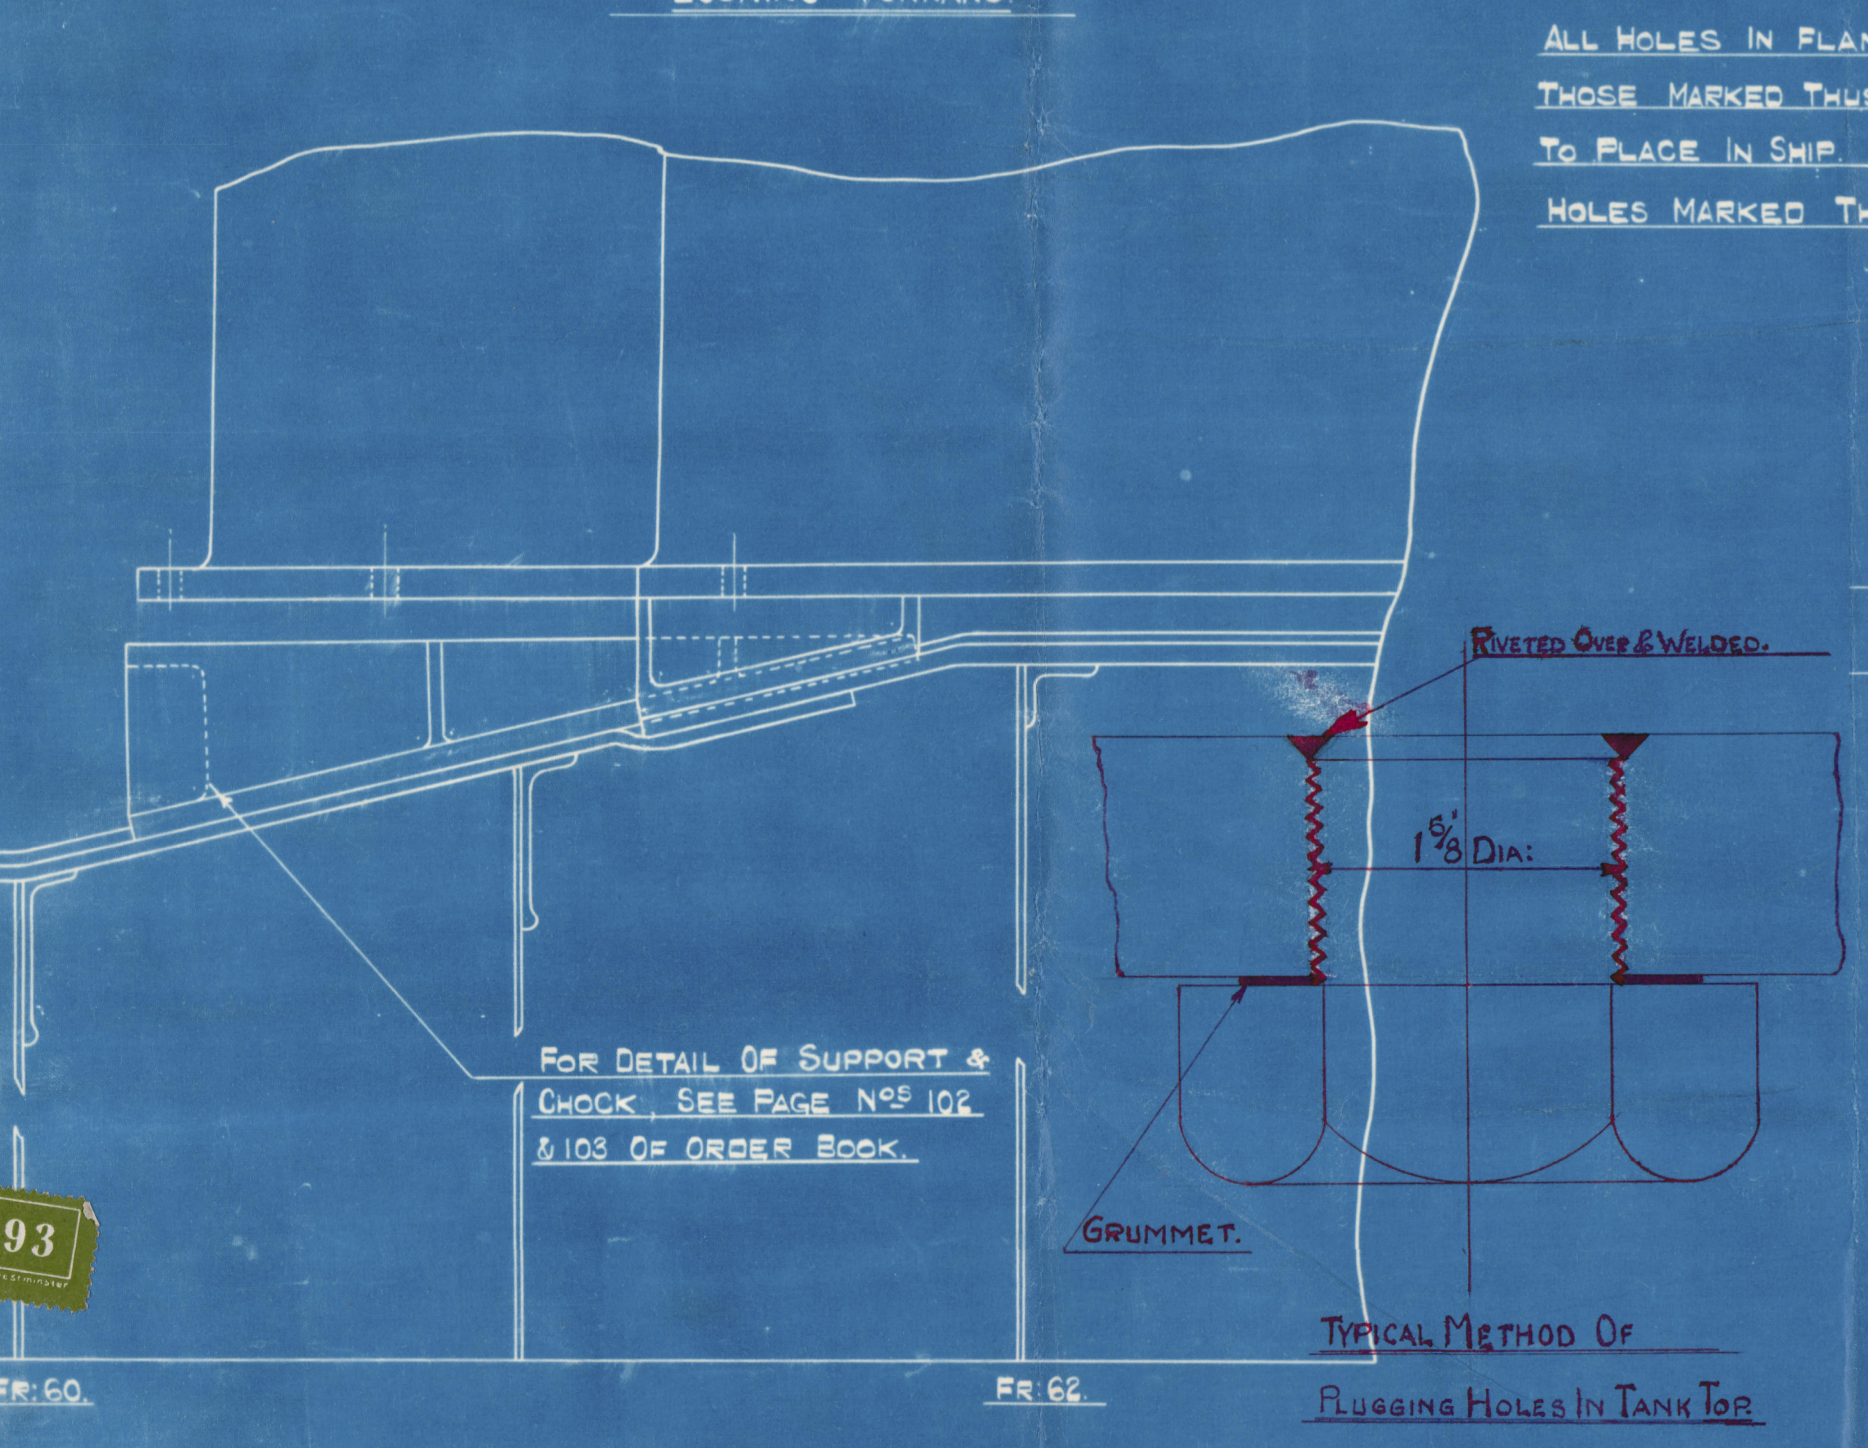
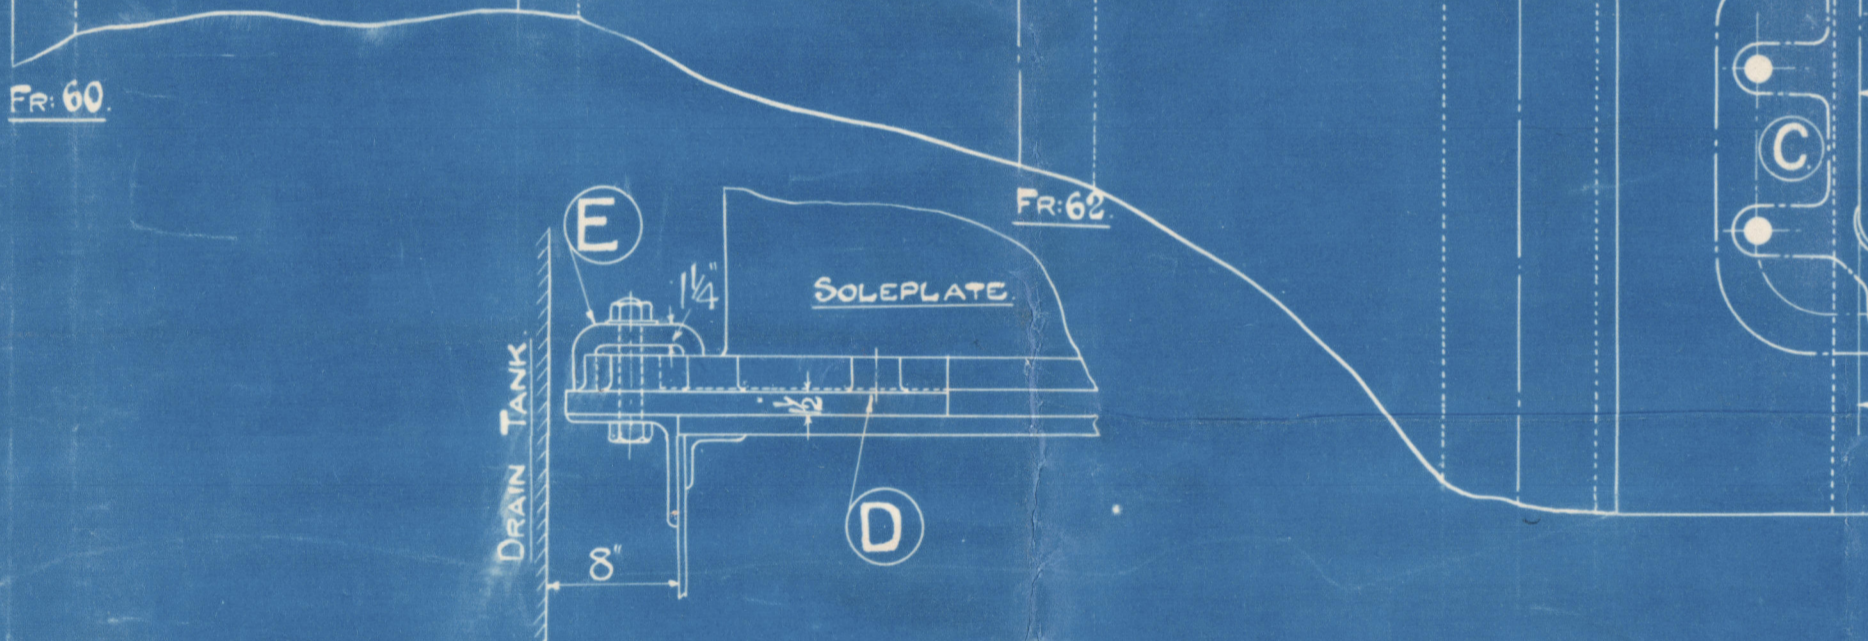
HOLES SHOWN IN RED ARE EXISTING HOLES IN TANK TOP AND HAVE TO BE PLUGGED AS SHOWN IN SKETCH.

TANK TOP TO BE CLEARED OF ALL ANGLES, ETC. IN WAY OF ENGINE AND TO BE FLUSH RIVETED BETWEEN FR: 60 & 75. CARE TO BE TAKEN THAT RIVETS DO NOT PROJECT ABOVE TANK TOP.
