BOILERS

ENGINE NO 698

Palmer & Co

Ship No 764

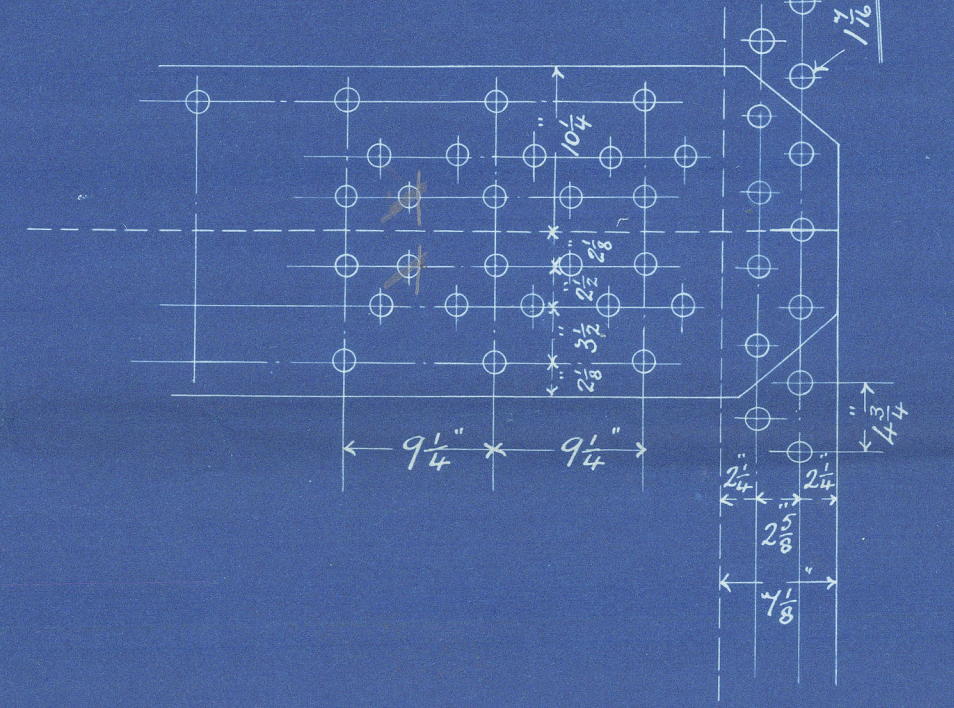
SHELL RIVETING
 DOUBLE BUTT STRAP JOINT
 SHELL PLATE $\frac{1}{8}$ " THICK BUTT STRAP $\frac{1}{8} + \frac{1}{16}$ "
 RIVET HOLES $\frac{1}{16} + \frac{1}{32}$ - GREATEST PITCH $9\frac{1}{4}$ "

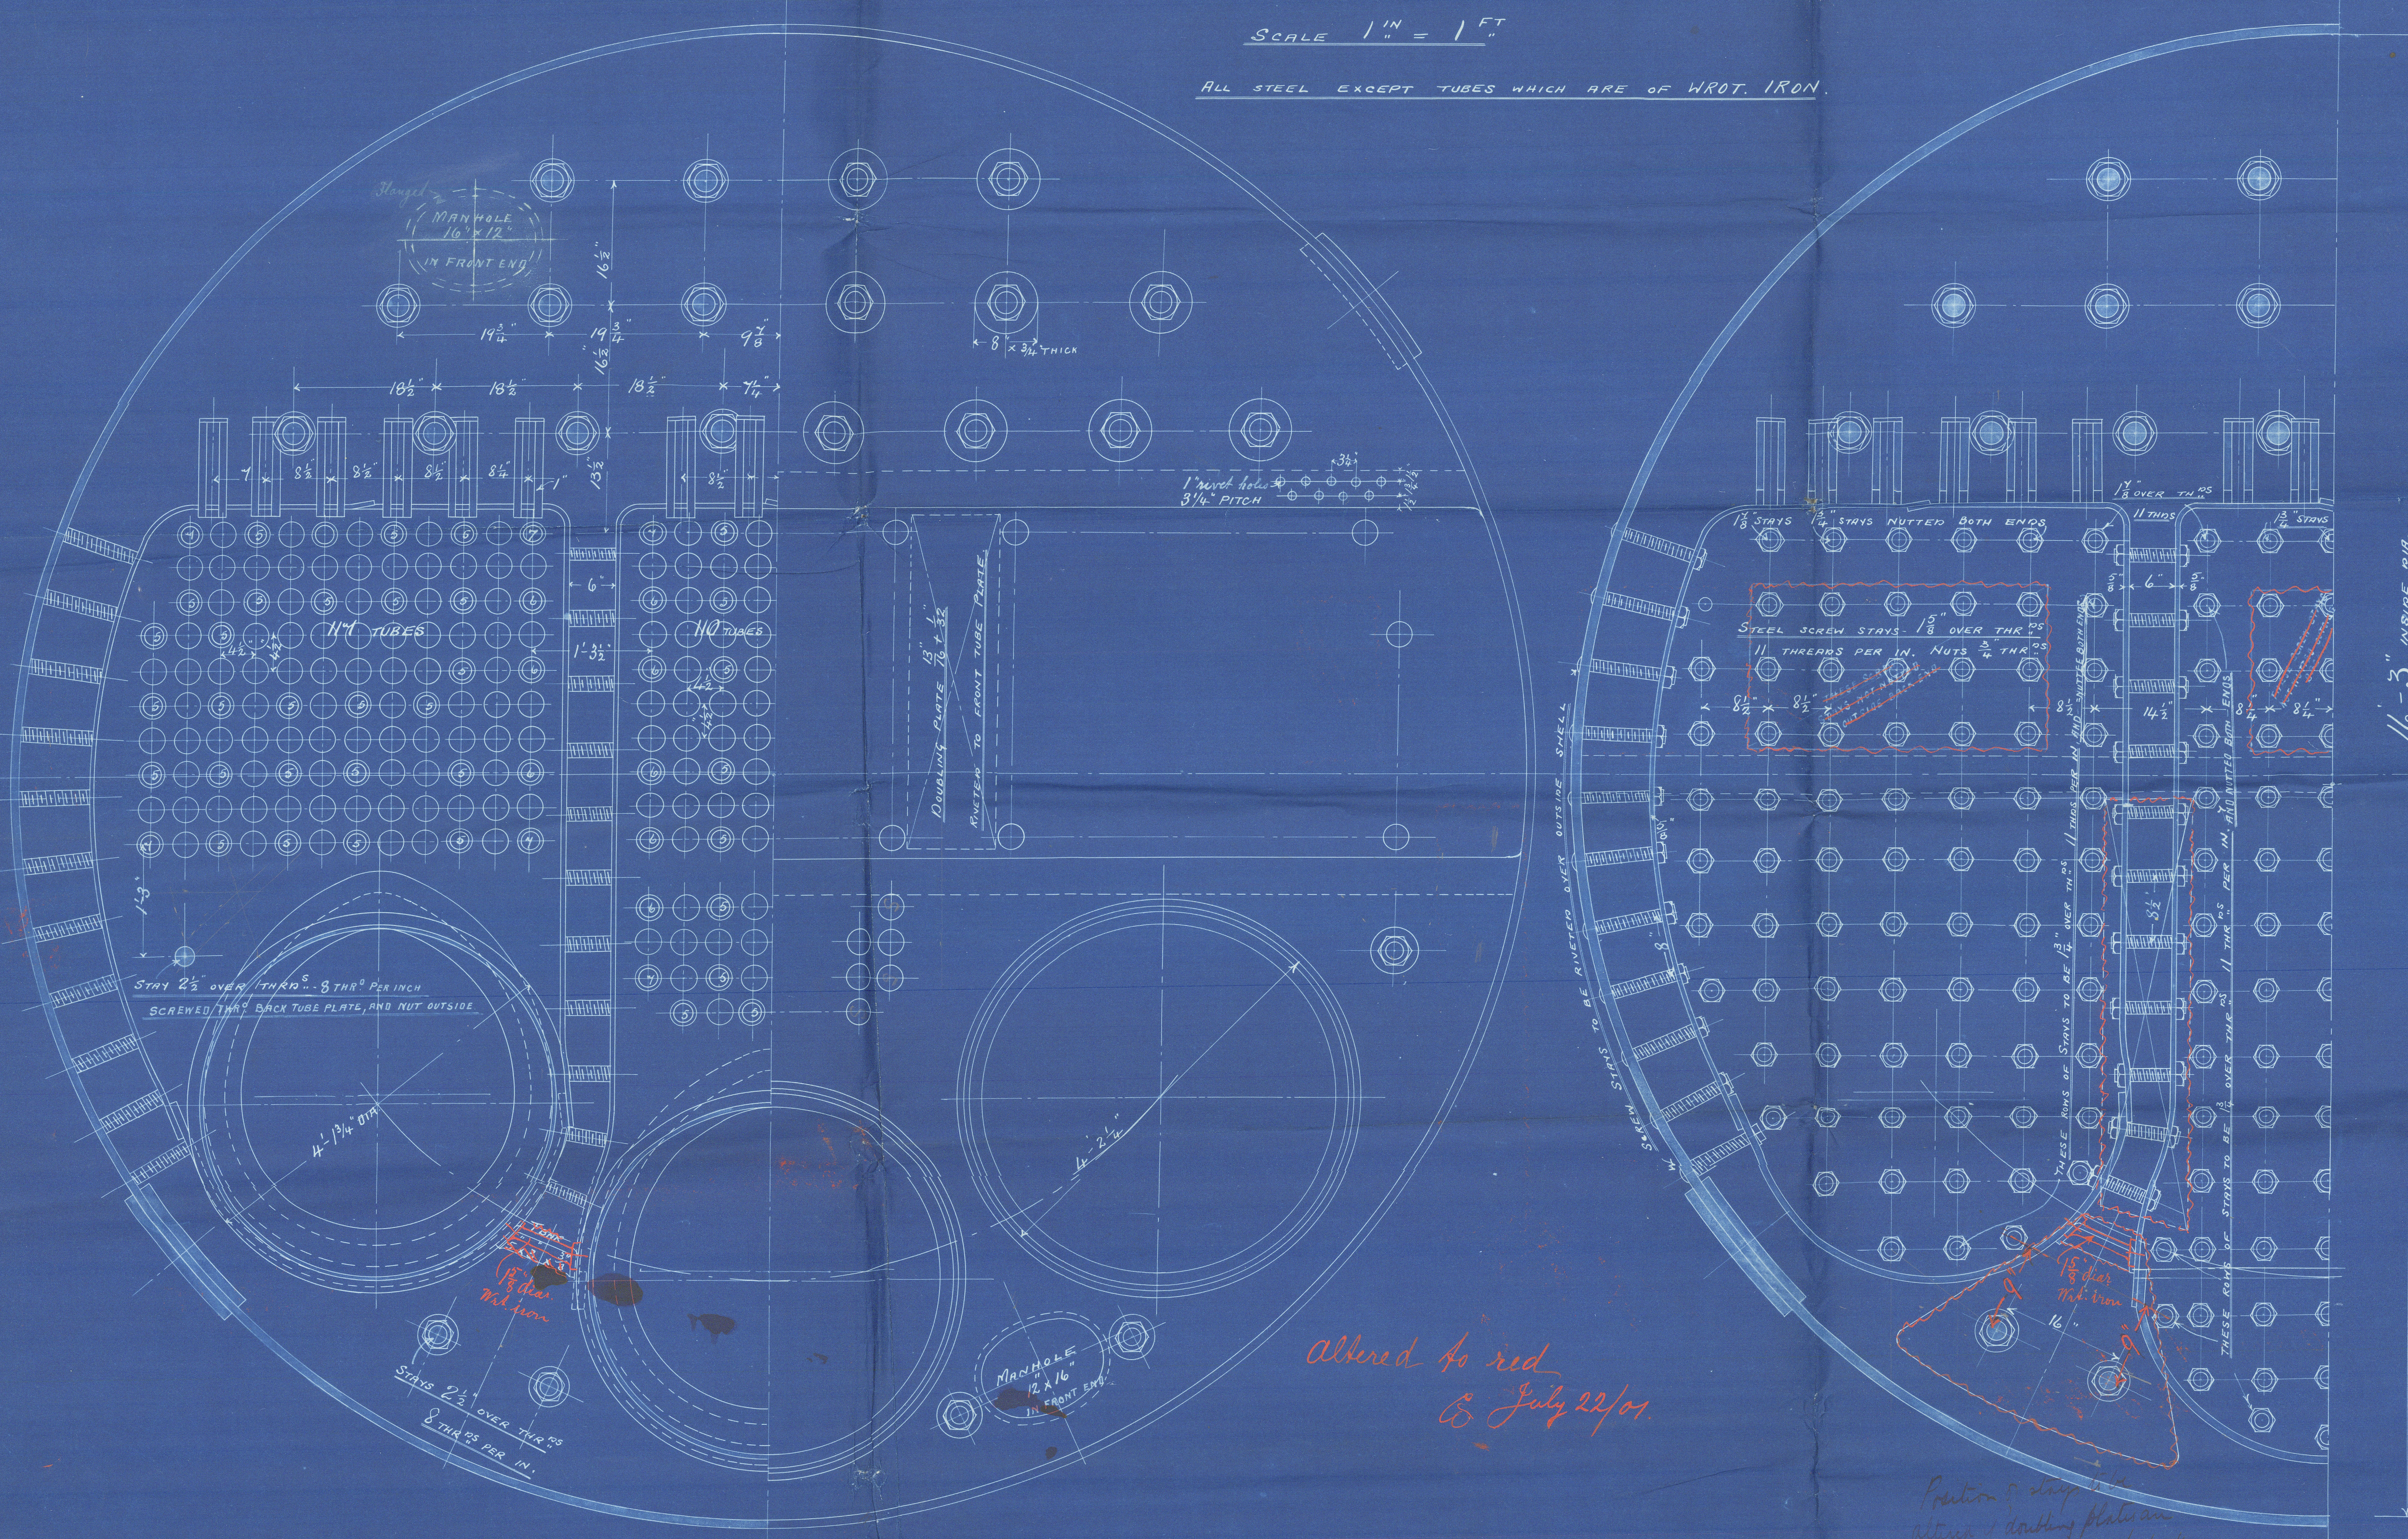
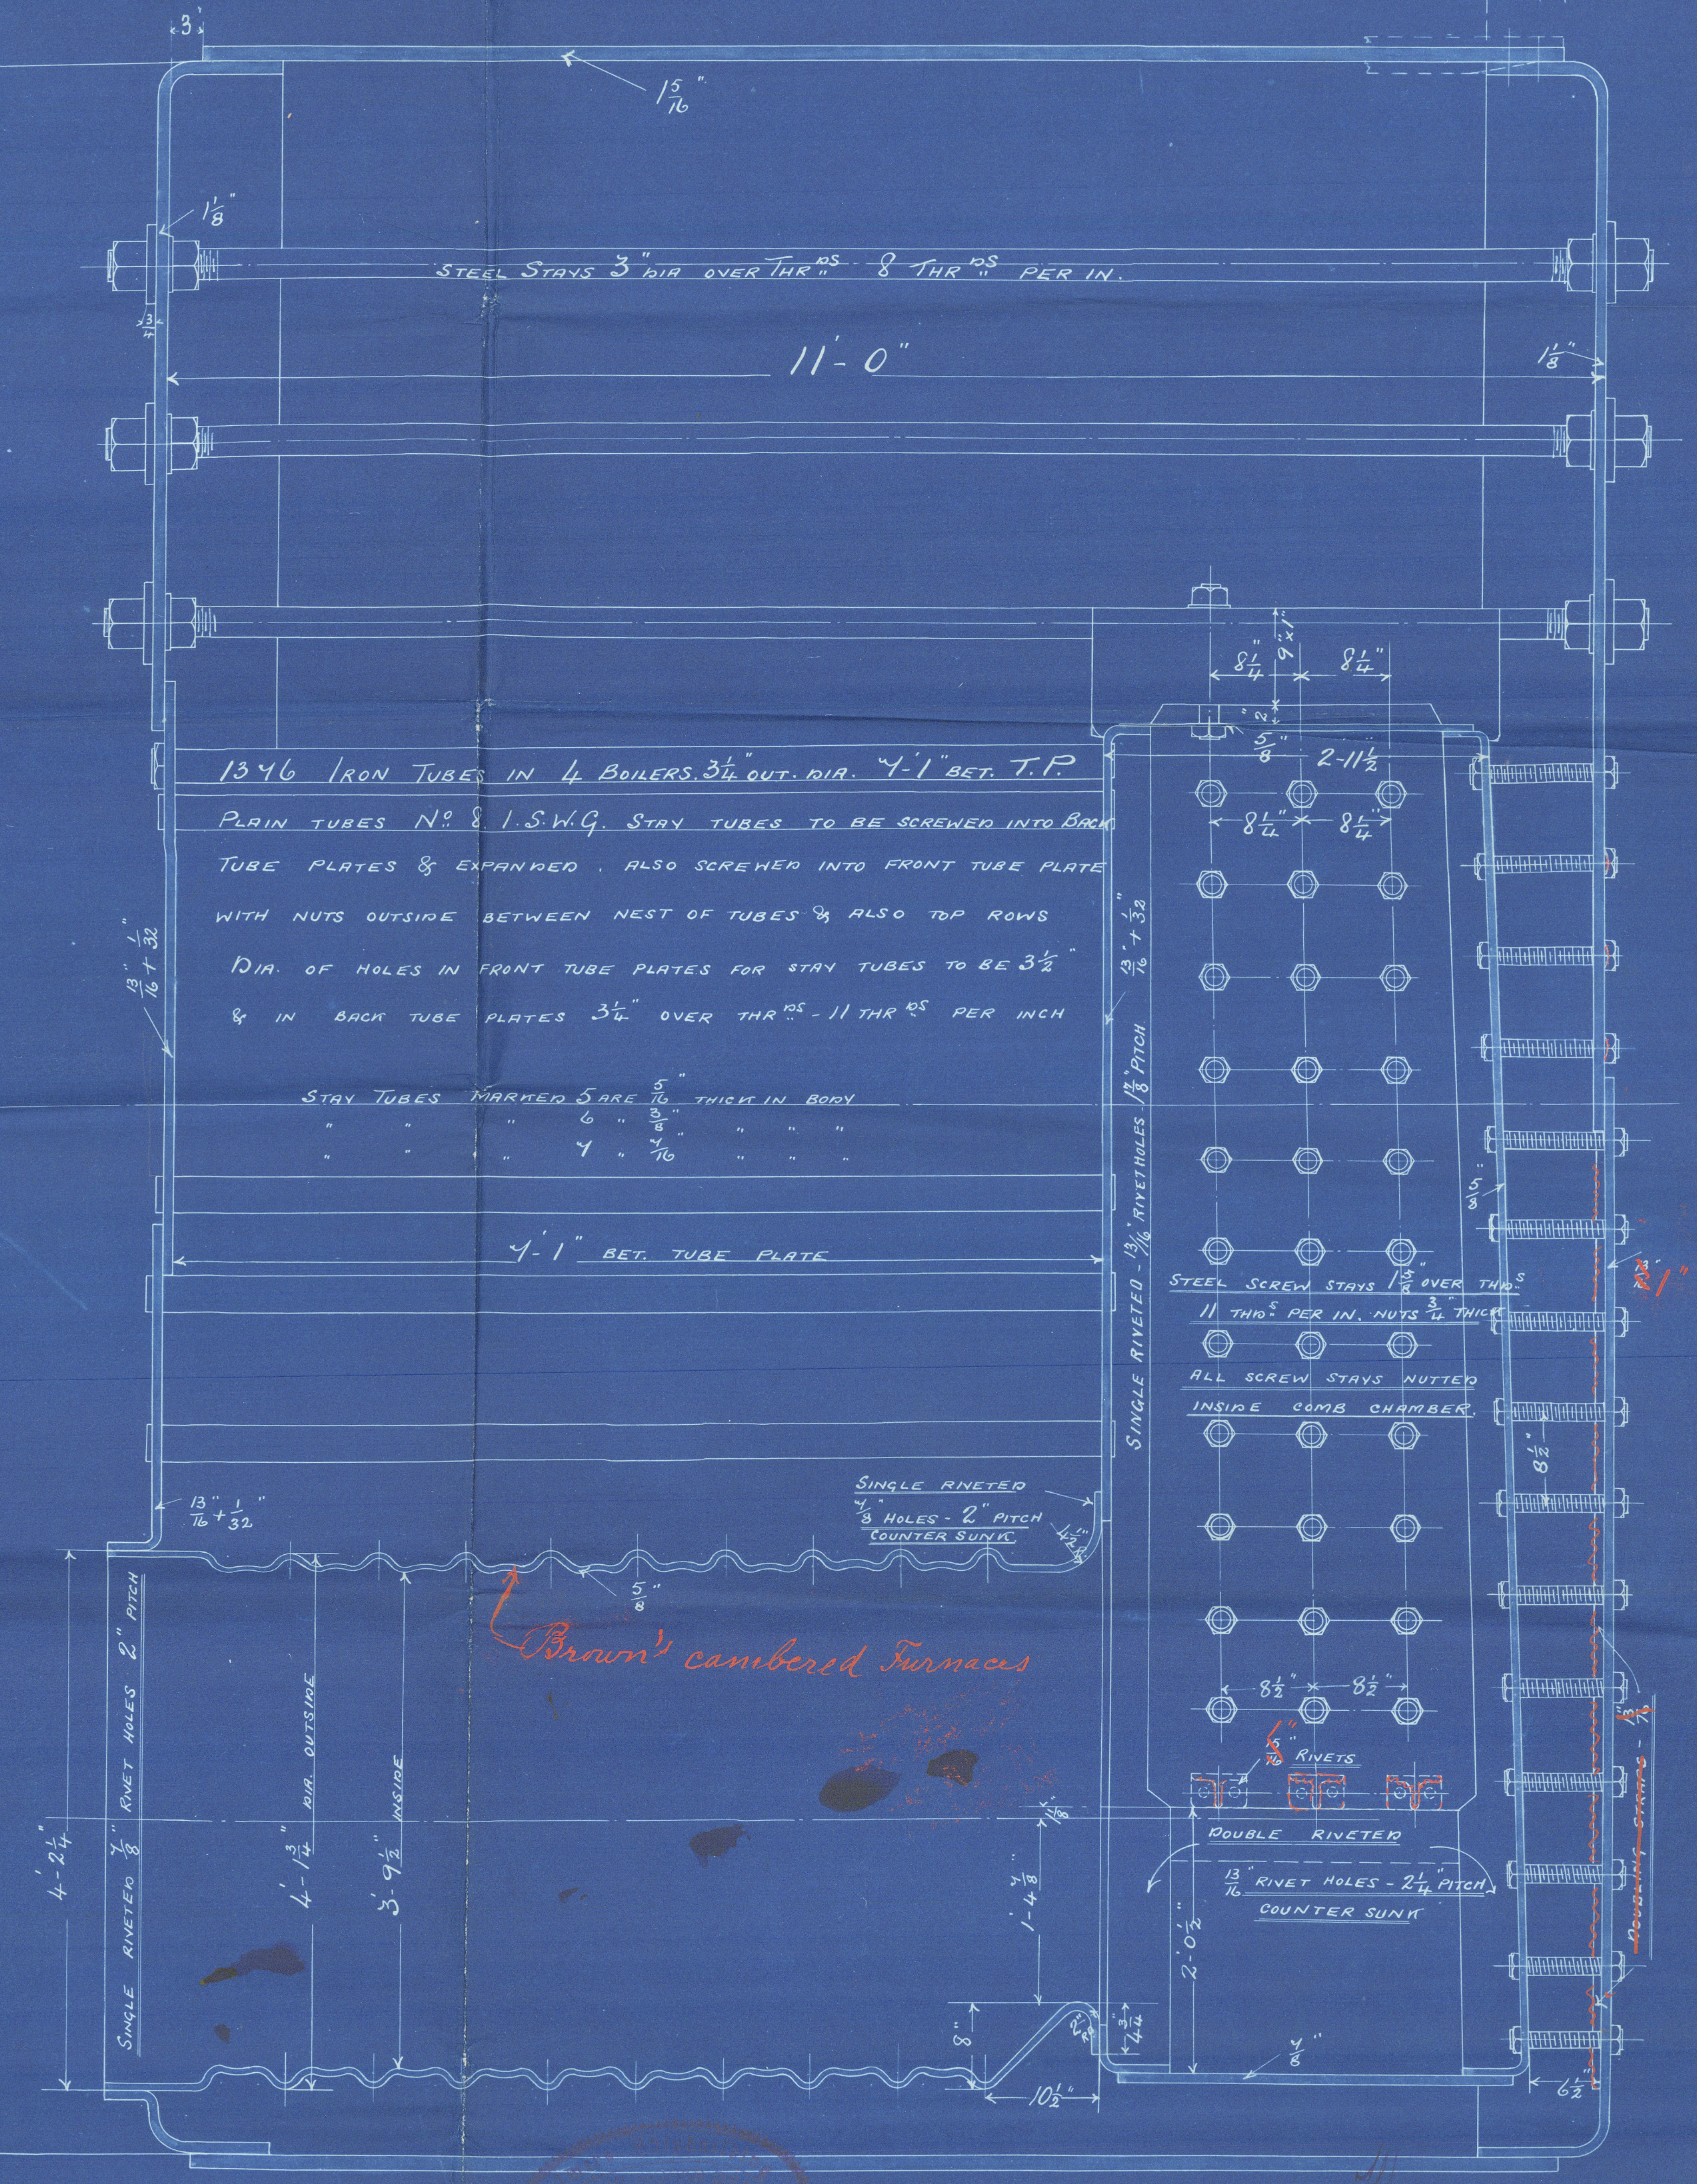
HEATING SURFACE IN 1 BOILER	
TUBES $3\frac{1}{4} \times 4-1 \times 34.4$	2070 sq
FURNACES	145 "
COMB CHAMBER	230 "
BACK TUBE PLATES	45 "
FRONT " "	40 "
	2530 sq
	4 B ²
TOTAL 4 B ² 10 120 sq	
WORKING PRESSURE	180 LBS
TEST "	360 "

CONDITION OF CONSTRUCTION	
LONGITUDINAL SEAMS DOUBLE BUTT STRAP JOINTS. CIRCUMFERENTIAL SEAMS DOUBLE RIVETER LAP JOINTS. ALL HOLES DRILLED IN PLACE AFTER BENDING THE PLATES THEN TAKEN APART & THE BURR TAKEN OFF & THE HOLES SLIGHTLY COUNTER SUNK FROM THE INSIDE	
LLOYDS	BUREAU VERITAS (DUTCH GOV)
TENSILE STRENGTH OF SHELL PLATE	29-32 TONS
CONSTANT USED FOR SHELL	22.55
" " " LONG STAYS	185
" " " SHORT "	135
" " " STAY TUBES	140 & 150
" " " RIVETS	24-27
TENSILE STRENGTH OF OTHER PLATES	26-30 TONS
CONSTANT USED FOR LONG STAYS	4/12.4
" " " RIVETS	86.95 (102 & 85)
" " " STAY TUBES	102 & 85
" " " RIVETS	85.75

ALL STEEL EXCEPT TUBES WHICH ARE OF WROT. IRON.

Position of stay
 within double plates
 low down with one of the
 one plate made thick
