S.T. BURFELL

Grimisby Report No 27838.

Repairs in way of outer plate.

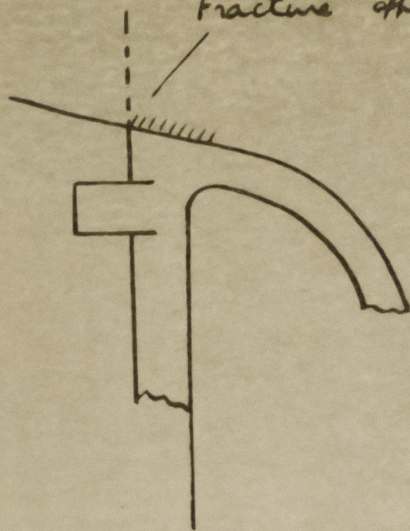
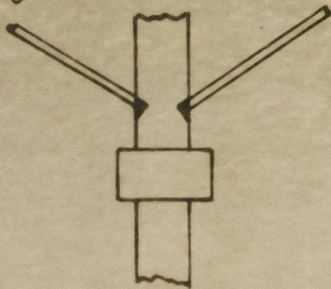
Fracture approx. 8" long x $\frac{1}{4}$ " deep (P+S) need out & E.W.
