S.T. STURDABERG

Grinsby Report No. 27836.

Repairs to boiler saturated steam safety valve chest.

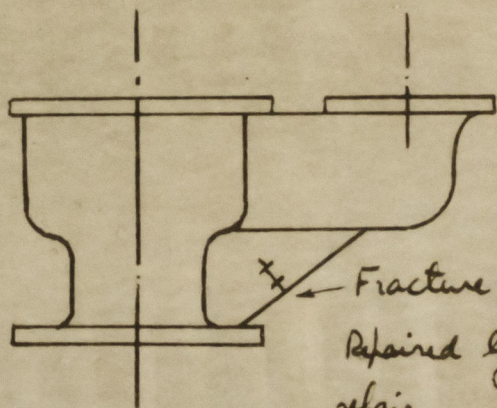
Fracture through web approximately $2\frac{1}{2}$ " long.
Repaired by "Key-Cast", similar to "Metalock" type of
repair.
