REPAIRED SKETCHES OF RUDDER

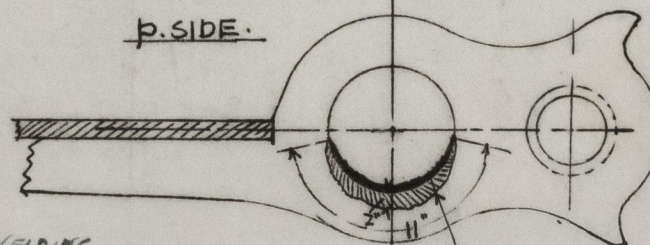
S. SIDE.

OLD E. WELDING
FRACTURED
✓ CORRODED
PART

~~CHIPPED &~~
~~ARC WELDED~~
QUASI ARC.
SYSTEM
