# THE STEEL COMPANY OF SCOTLAND, LIMITED.

Test Room Sheet

CHARGE No.	SAMPLE No.	SIZE OF SAMPLE.			SIZE OF FRACTURE.				INITIAL STRAIN.		BREAKING STRAIN.		LENGTH.		EXTENSION.		CONDITION.		QUALITY.	ORDER No.
		Bth.	Thk.	Area.	Bth.	Thk.	Area.	%	Actual Tons.	Per sq " Tons.	Actual Tons.	Per sq " Tons.	Before Breaking.	After Breaking.	% Ins.	% Ins.	Annealed or Unannealed.	Long or Cross.		
	H.W	1.24	.48	.595							18.5	31.0			2.5					
Messrs Harland & Wolff's Stern Frame for 223 Ship

48 Wolffe 223  
Stern Frame Castings  
March 25<sup>th</sup> 89

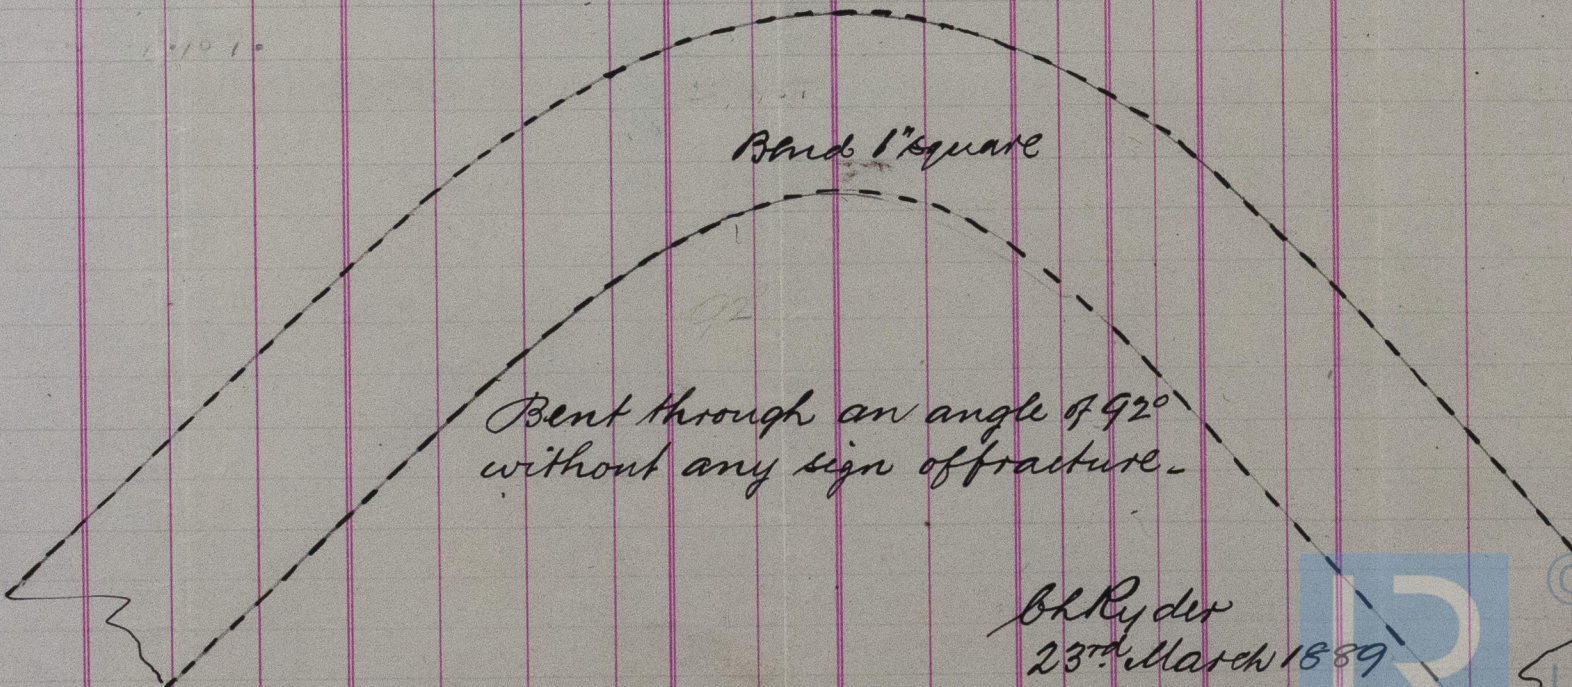
<p>Bent 1' square</p> <p>Bent through an angle of 92° without any sign of fracture.</p> <p>B. Ryder 23<sup>rd</sup> March 1889</p>
