"HERTFORD."

Syd 18,671.

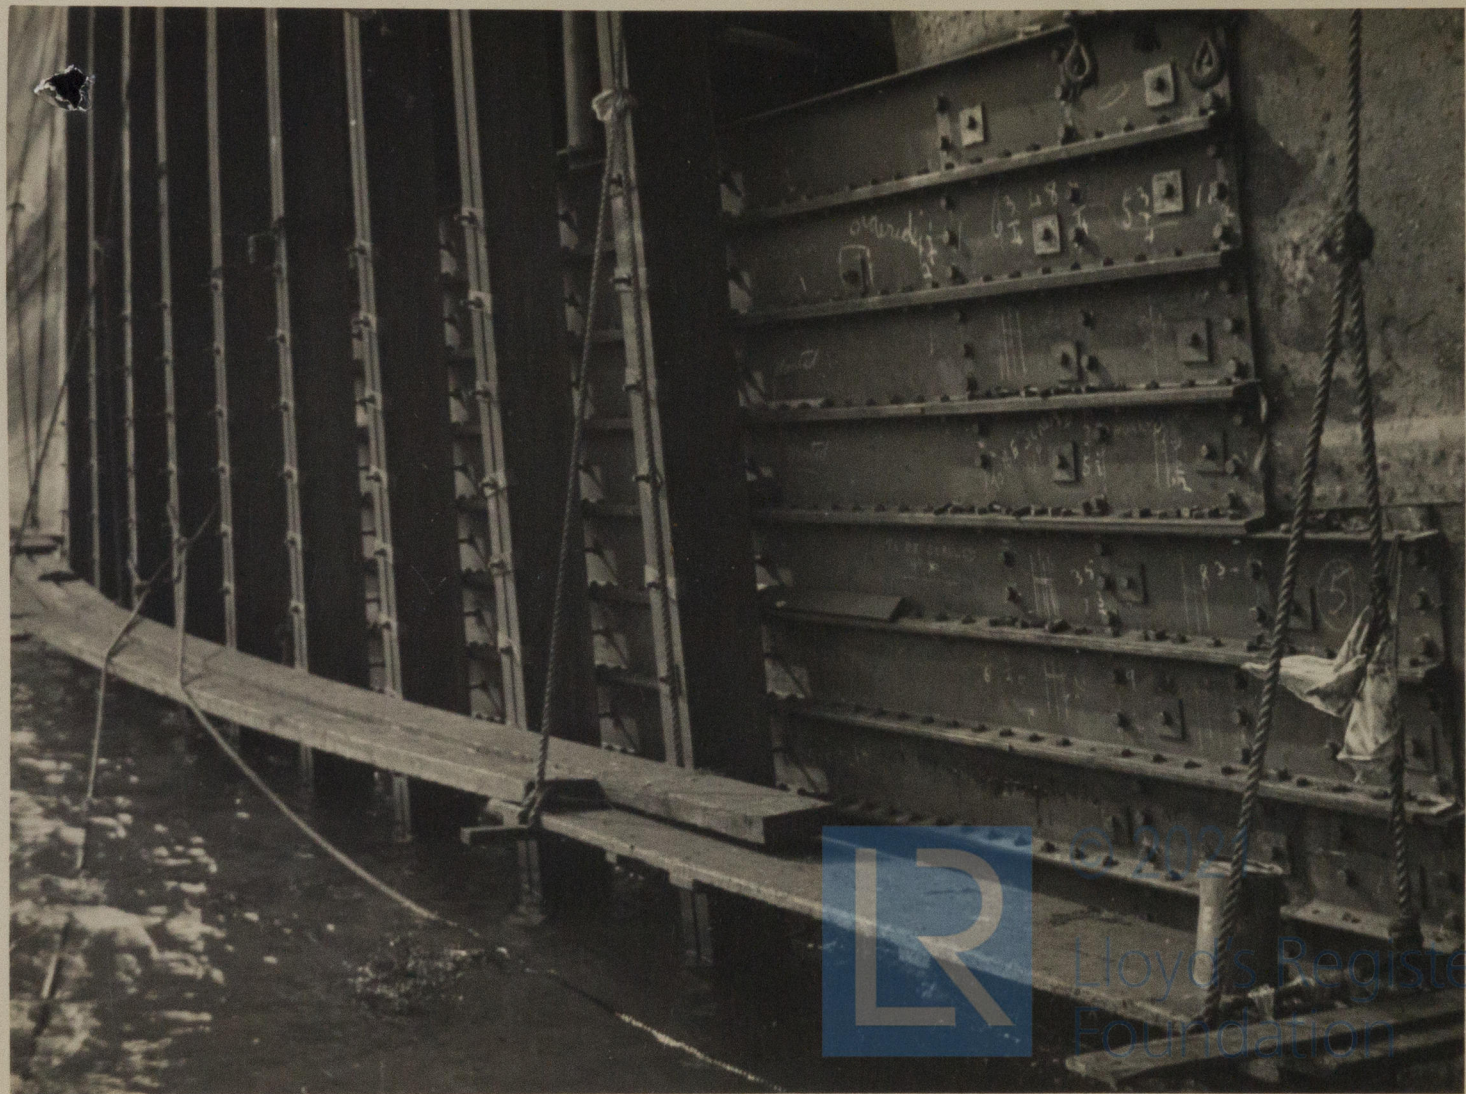
No. 1
Fore end of patch showing method
of securing channels.

View after holds pumped out &
Scargo discharged.

Ends of channels being efficiently
connected to shell plating (for. & aft.)
