W/18P-0003

S/S "LLANCARVAN."

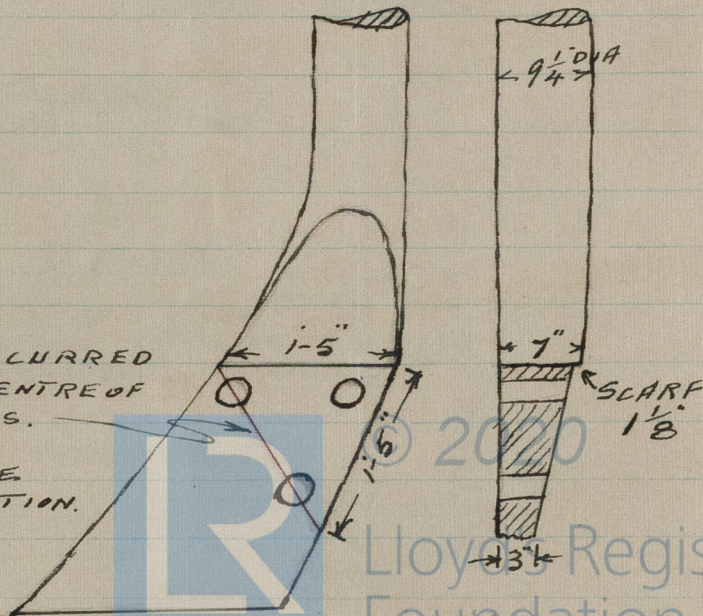
BREAK OCCURRED
THROUGH CENTRE OF
BOLT HOLES.

UNDERPALM BROKE IN SAME
POSITION.

These are the only details I have, the material having
been disposed of when the clearing letter arrived.
