6	Muttere	3	SMS	Smig.	✓				
6	Kuplingsbolter	2	-	-	✓				
1	Veivaksel i 2 deler	1	SMS	Smig.	✓	8580			
ANTAL		GJENSTAND		NR.	MATR.	GODS MODEL VEKT			
		VEIVAKSEL				DATO	TEGN.	KFR.	
						30	36	46	46
						FORANDRET			
		ORDRE NR.							
		LEVERES TIL	Dampmotor $2 \times \frac{425 \times 1015}{930} \times 15,5 \text{ kg/cm}^2$						
			HOVED NR: 23				STØRRELSE: 8 ^a		
			SKALA: -				ERST. FOR: - © 2019		
			1:15 & 1:4				M-10683		
1	1	ANT.	A/S FREDRIKSSTAD MEK. VERKSTED				ERST. AV: -

Crankschaft

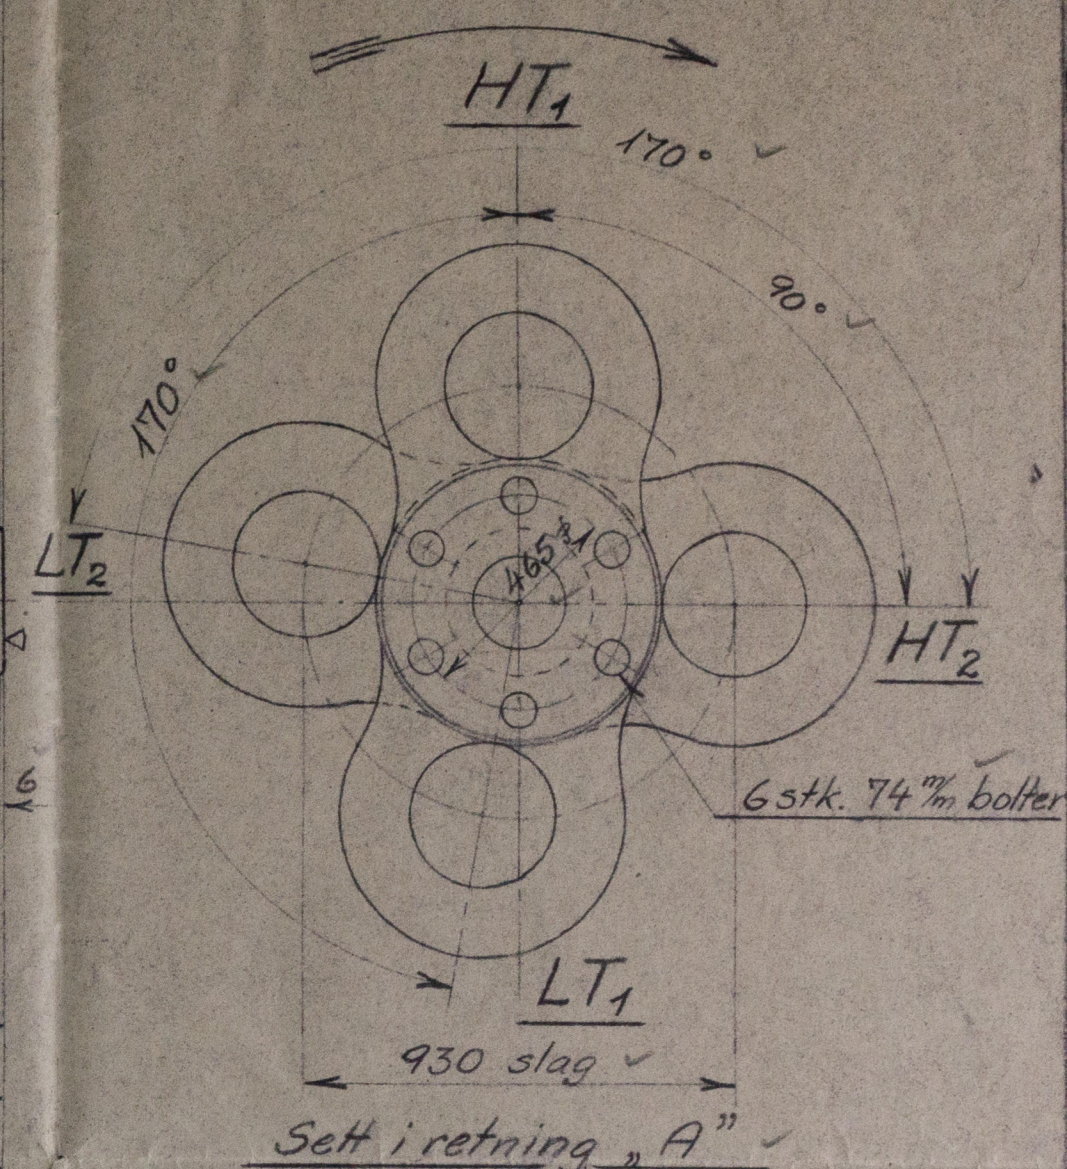
M-10683

Ingen kiler i nålen ✓

Kilene i HT_2 forreste
veivarm sløifes. ✓

$$\sqrt[3]{\frac{16,555 \times 930 \times 1015^2 \times 2}{136 \times (2 + \frac{1015^2}{425^2})}} = \underline{\underline{311,68 \text{ m/m} \checkmark}}$$
